Aerosmith Fastening Systems
5621 Dividend Road,
Indianapolis, Indiana 46241

Date: December 12, 2021
Author: Luke Tavernit
Report Number: ESP036520P.1R0

**ICC AC257 CONDITION 3 CORROSION RESISTANCE TEST
OF AEROSMITH SURE-BOLT EXTREME SCREW FASTENERS**

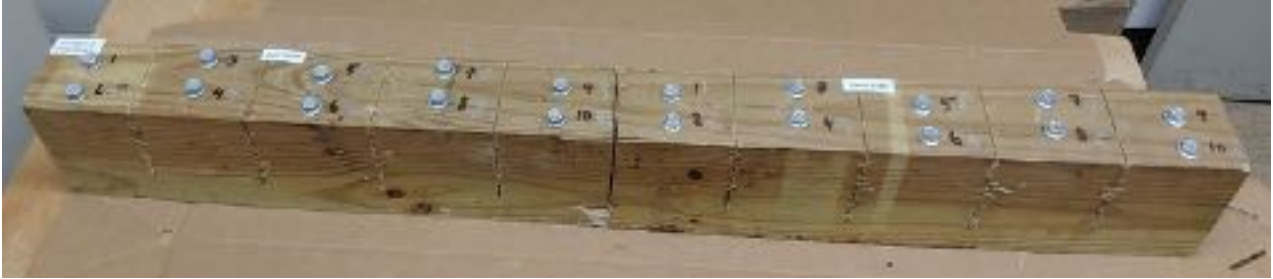
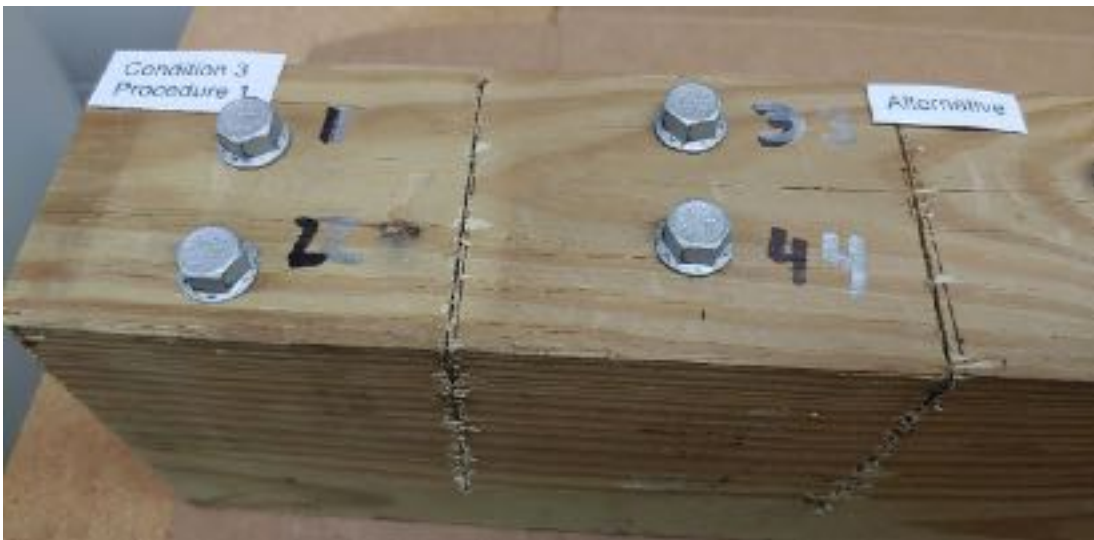
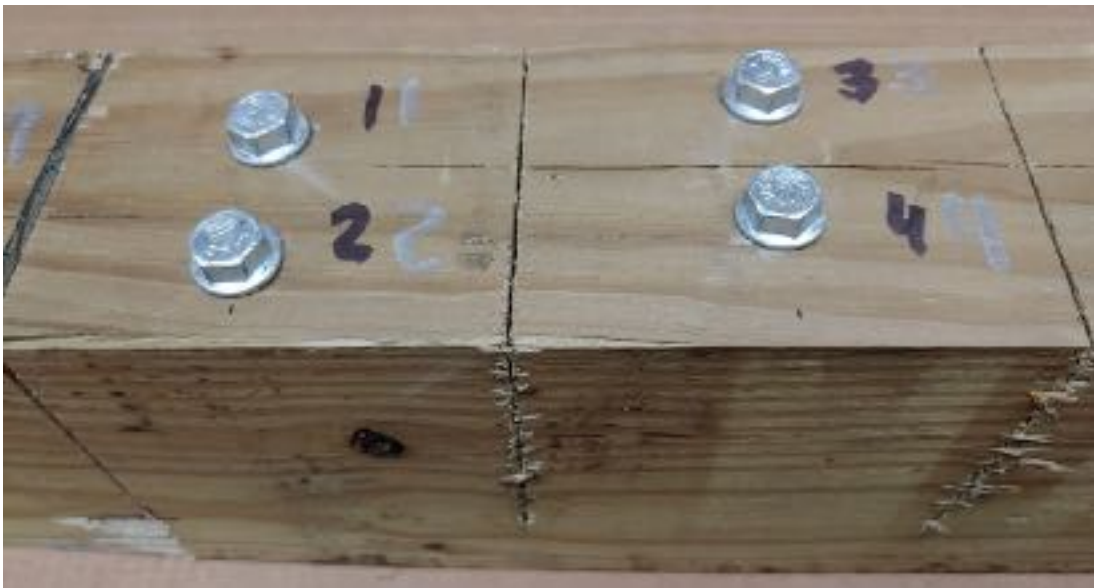
Procedure 1 (ASTM B117 exposure) Condition 3 (moisture) Test Board Set-up

Ten (10) fasteners were randomly selected from the group submitted and cleaned per ASTM G1 ultrasonically in deionized water at room temperature with a 7.5 minute submersion time. Test boards were cut from the boards noted above and assigned to the Procedure 1 and Procedure 2 exposures as noted. The screws with the coating system along with a set of the benchmark Hot Dip Galvanized were installed in groups into the 4” face and across the test boards spaced at least 12 fastener diameters apart, in a staggered pattern along center lines following the spacing requirements in AC257 section 4.1.5. With the fasteners to be no closer than 2 inches from either end with 1 ½ inches of space between them along the length of the board keeping them at least ½ in. from the edge of the boards. The fasteners were inserted without pre-drilled pilot holes into treated wood members using drive-heads of the recommended size. After all fasteners were inserted, kerf-cuts were made between them across the boards that were as deep as the fasteners penetrated the test boards as pictured below.

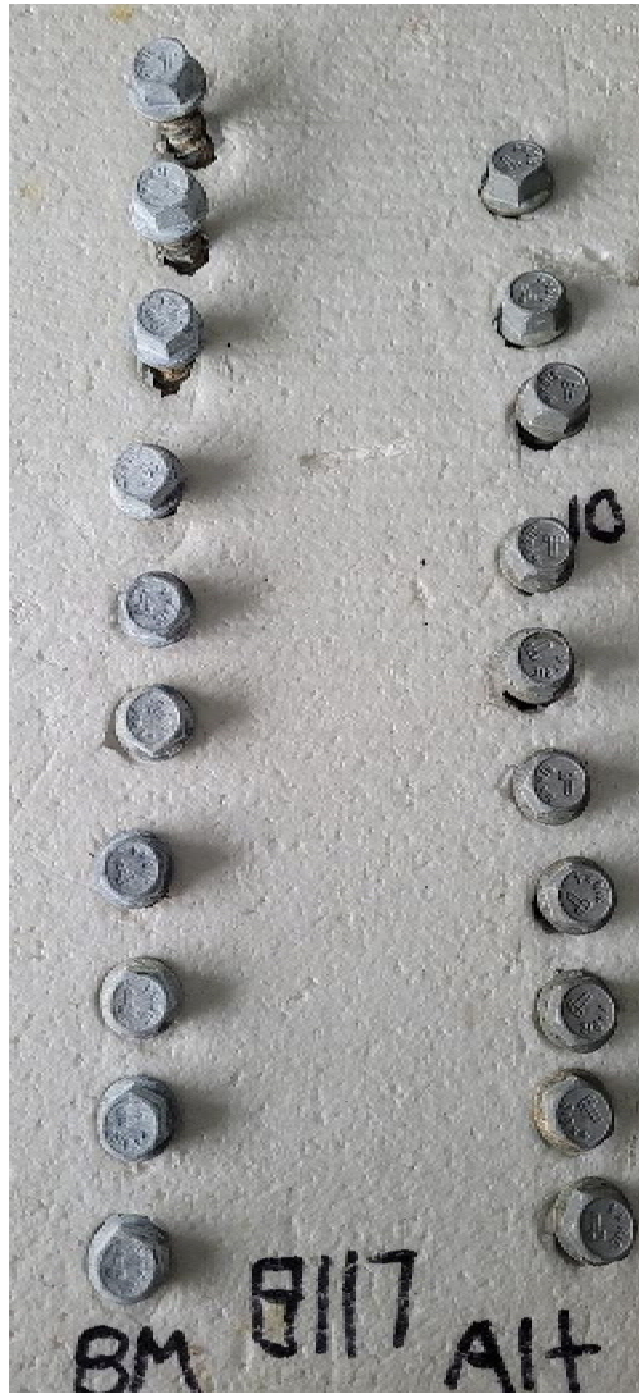
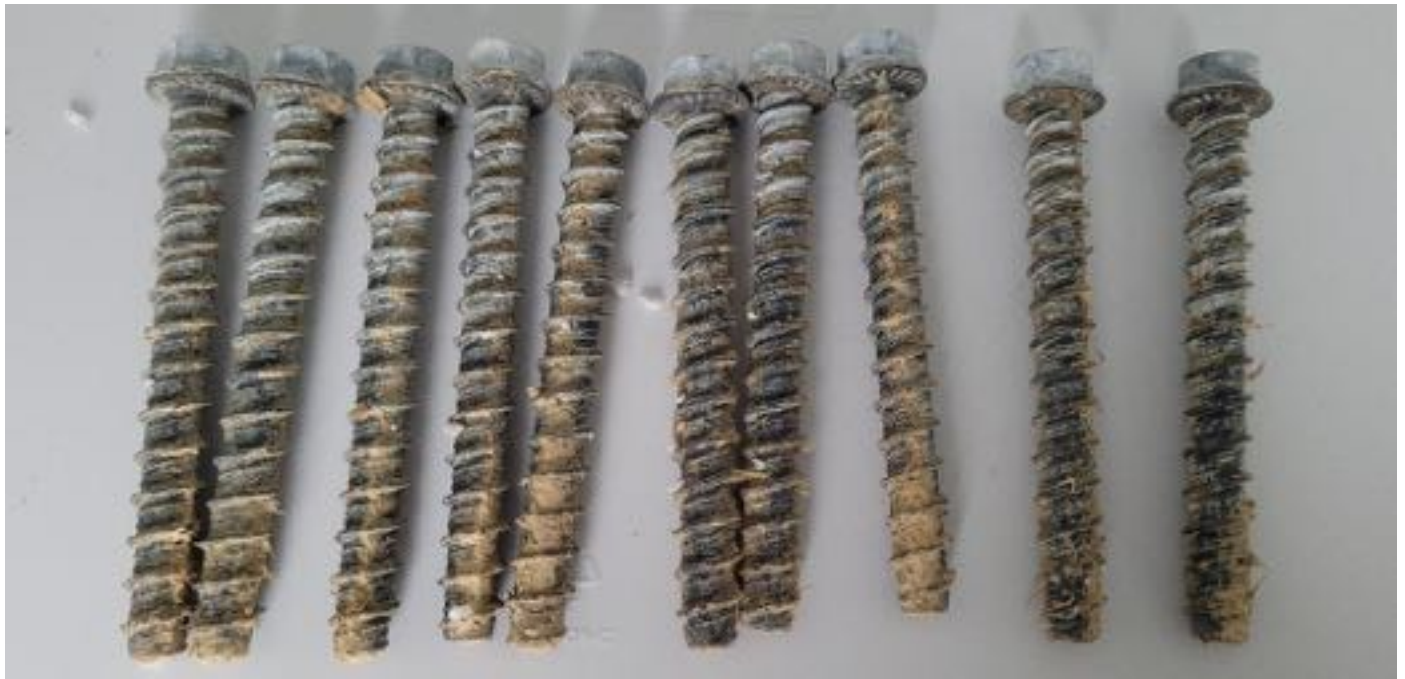
Benchmark Fasteners

Photographs Benchmark and Alternate following 1440 hours of B117 exposure

Note: the photographs on Pages 13 and 16 show some wood stuck to the surface of the threaded portion of the screws. In some cases this look a little bit red, however these areas are generally not rust, rather it is just the color of the wood.

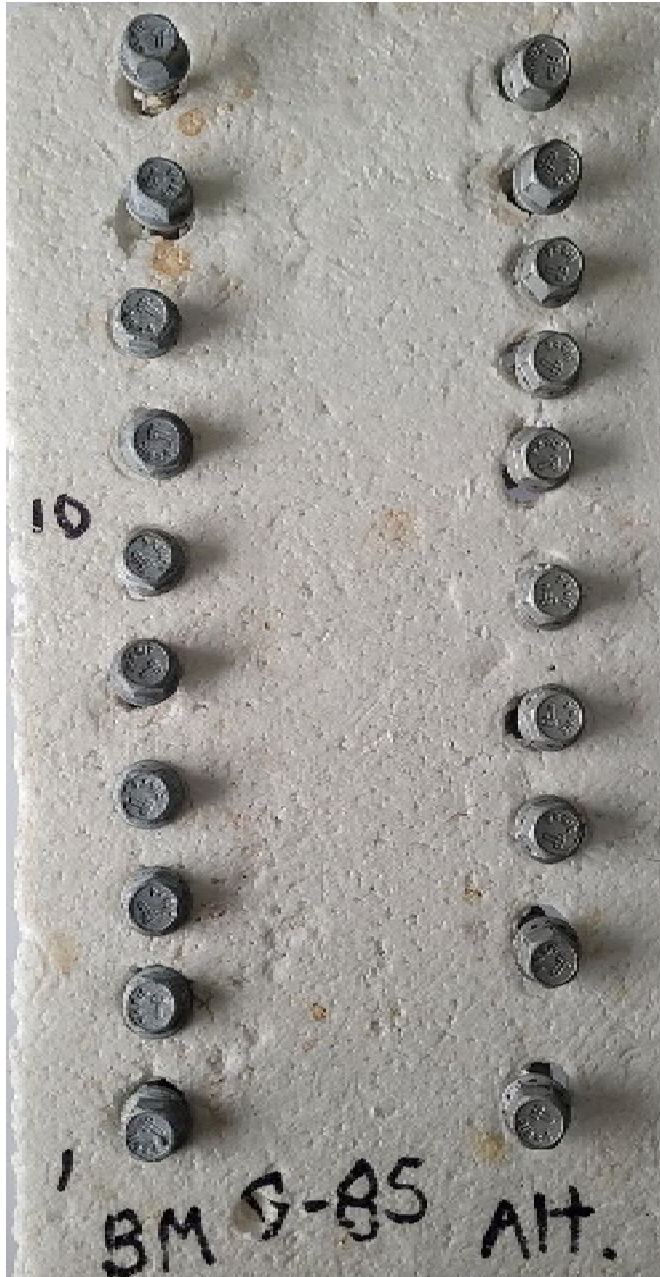
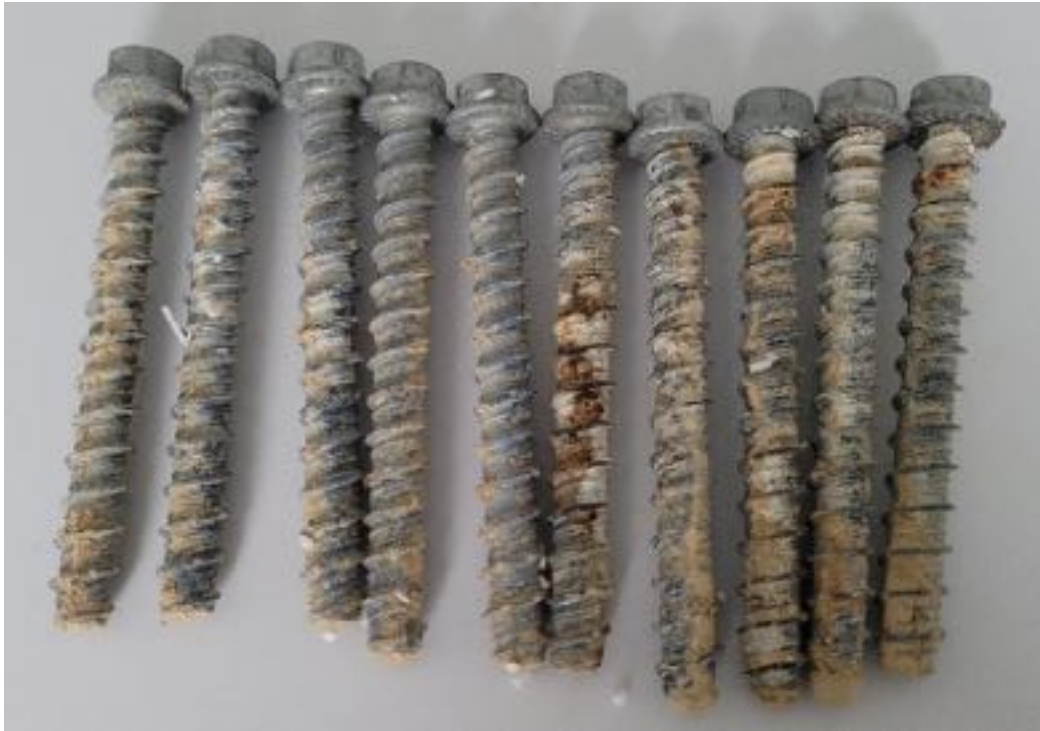
Benchmark Fasteners

Photographs Benchmark and Alternate following 1440 hours of G-85 exposure
